# Barton & Loguidice

**Re:** Lewis County Rails-to-Trails  
Condition Assessment Memorandum

**Date:** November 9, 2022

**Project No.:** 296.046.001

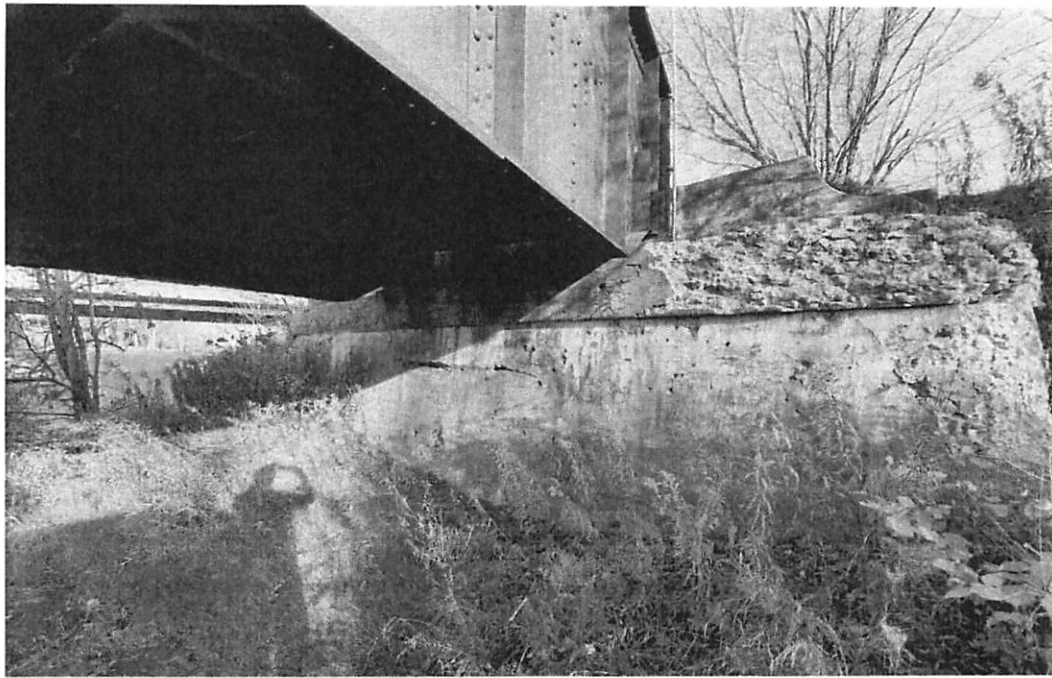
Photo No. 3

The north abutment cast-in-place concrete and is in fair condition exhibiting moderate deterioration in the form of spalled and hollow sounding concrete. The abutment has a full width horizontal crack at mid-height and widespread cracking and efflorescence on the face. The bearing areas are not undermined but have similar deterioration (e.g. spalled concrete) to the face of the abutment. The abutment backwall is in fair condition with minimal deterioration.

North Abutment

Class A and D concrete repair is proposed at the north abutment. This work is needed to address existing cracking and spalling to extend the service life of the existing abutment. It is anticipated that this work can be performed from the bank and will not require cofferdams or water access.

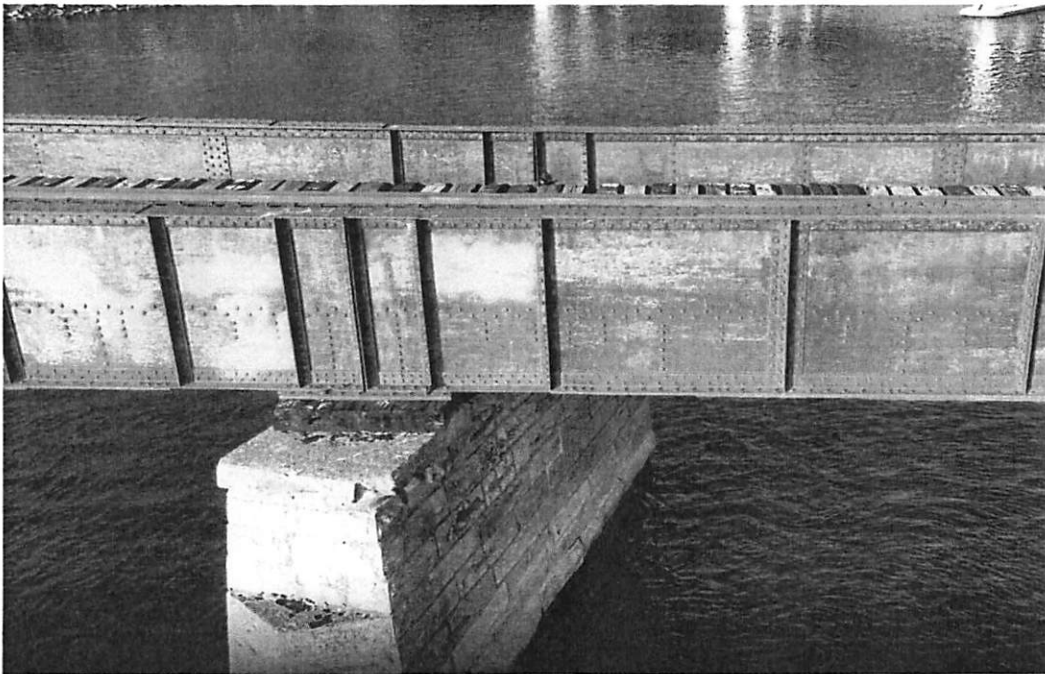
Photo No. 6

Known settlement of piers 3 and 4 has occurred at this site. These piers have settled approximately 12". The cause of settlement is unknown but most likely attributable to undermining and scour from the Black River's flow, or due to the decay of a timber cribbing support system, should one exist.

Pier 3

Replacement of the deteriorated timber bearings is proposed at piers 3, 4 and 6. A steel bolster or similar element will need to be considered to maintain existing geometry. Structural lifting will be required for this work. It is anticipated that structural lifting can be completed from the existing bridge seat and this will not require cofferdams or water access.

Installation of grout bags is proposed at the base of piers 3 and 4 as a preventative measure against further settlement of these piers. The cause of settlement at these locations is unknown but may be related to scour. Installation of grout bags as a preventative measure against settlement or corrective measure against scour will extend the service life of the piers.

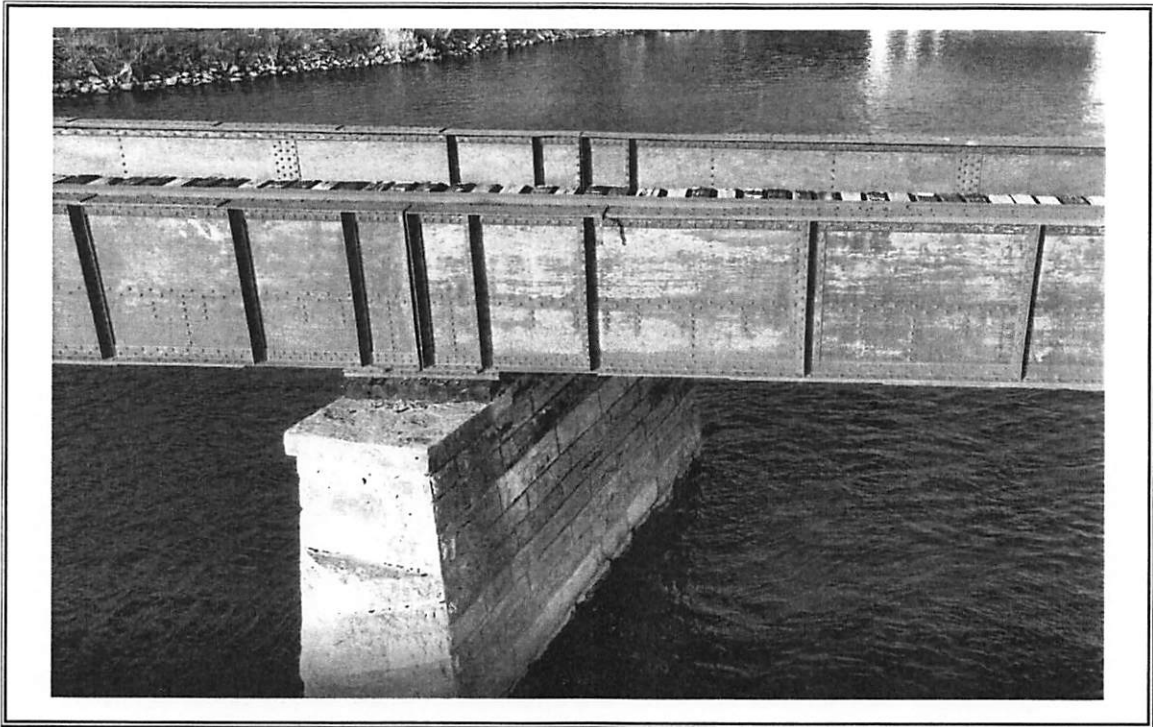
Photo No. 7

Pier 4

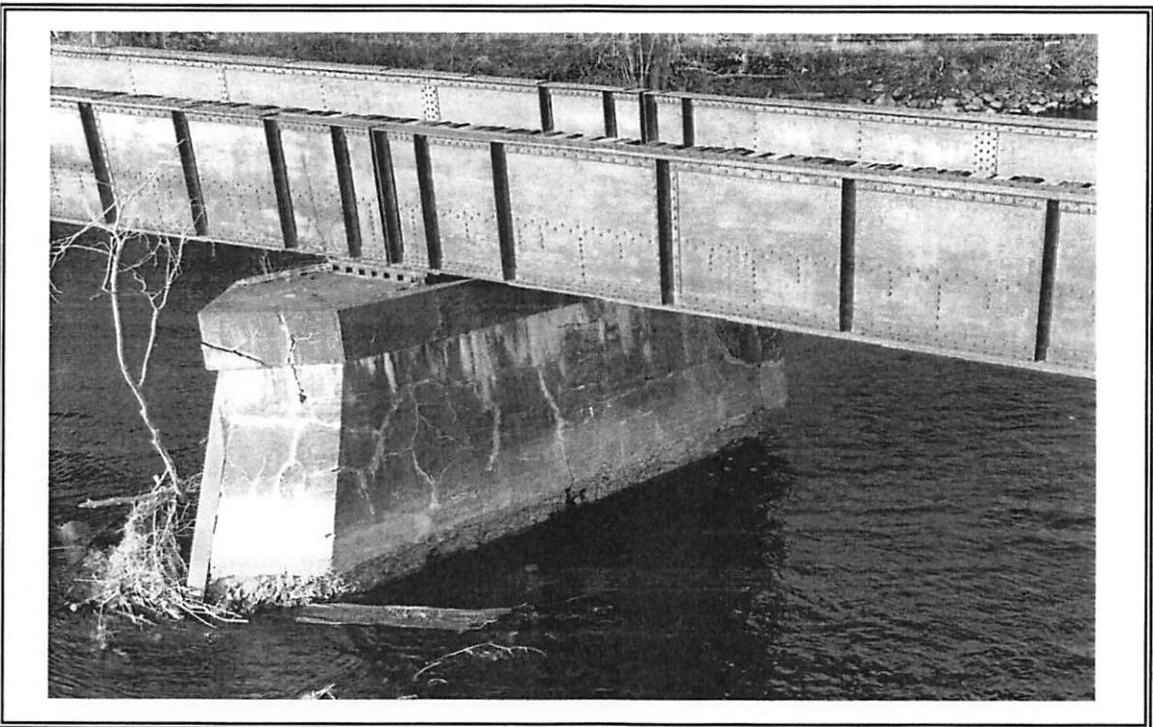
Photo No. 8

Pier 5

Class A and D concrete repair is proposed at the pier 5. This work is needed to address existing cracking and spalling to extend the service life of the existing pier. It is anticipated that this work will require cofferdams and water access.

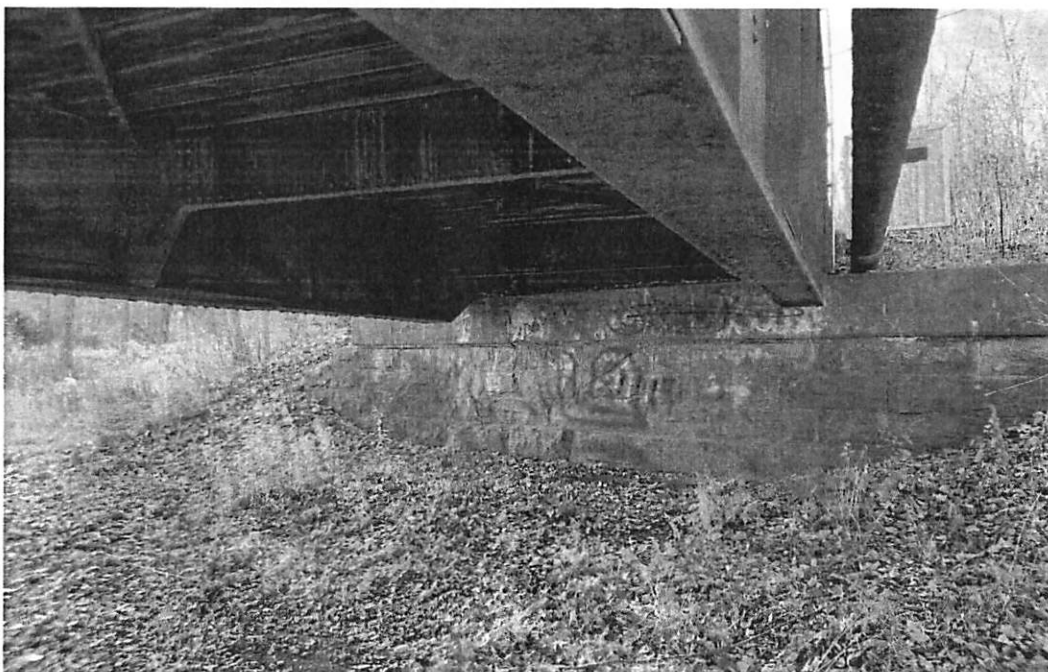
Photo No. 10

The south abutment is a stone abutment with a concrete cap and is in fair condition. There are no apparent issues with mortar quality or loss between stones. The concrete cap is in fair condition with minor cracking. The bearing areas are not undermined. The concrete backwall is in fair condition with minor cracking.

South Abutment

No concrete repair is proposed at the south abutment and piers 1-4 and 6. Existing deterioration is minimal and does not require rehabilitative work to extend the service life.

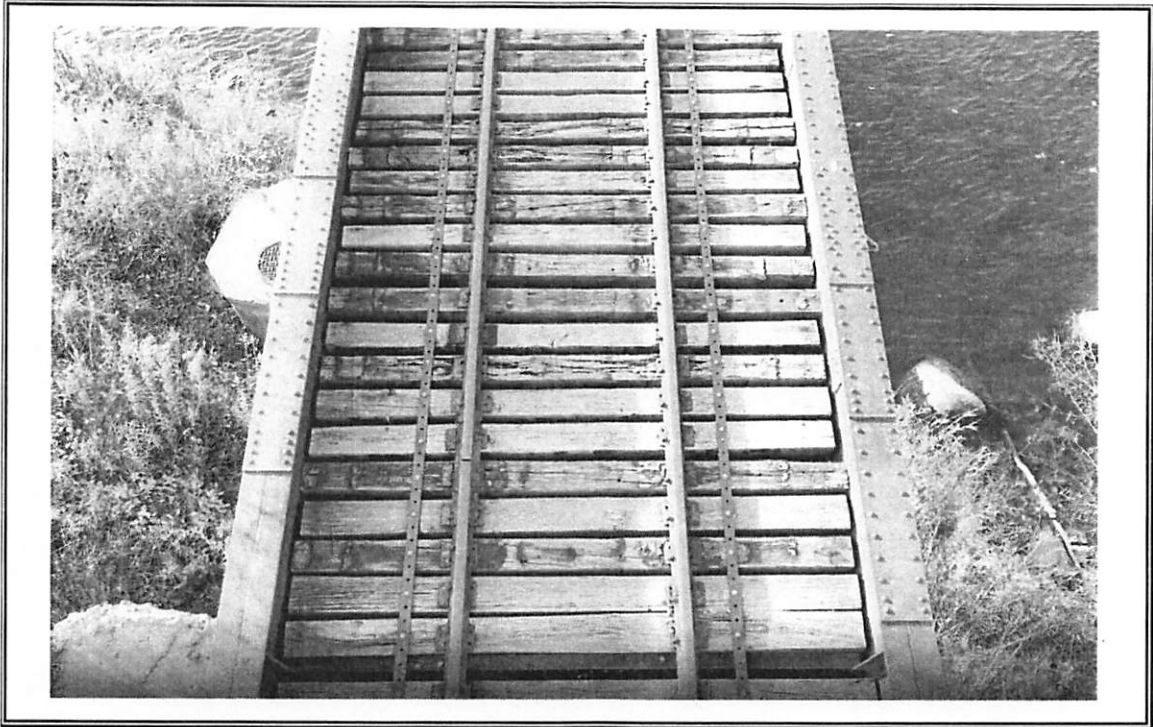
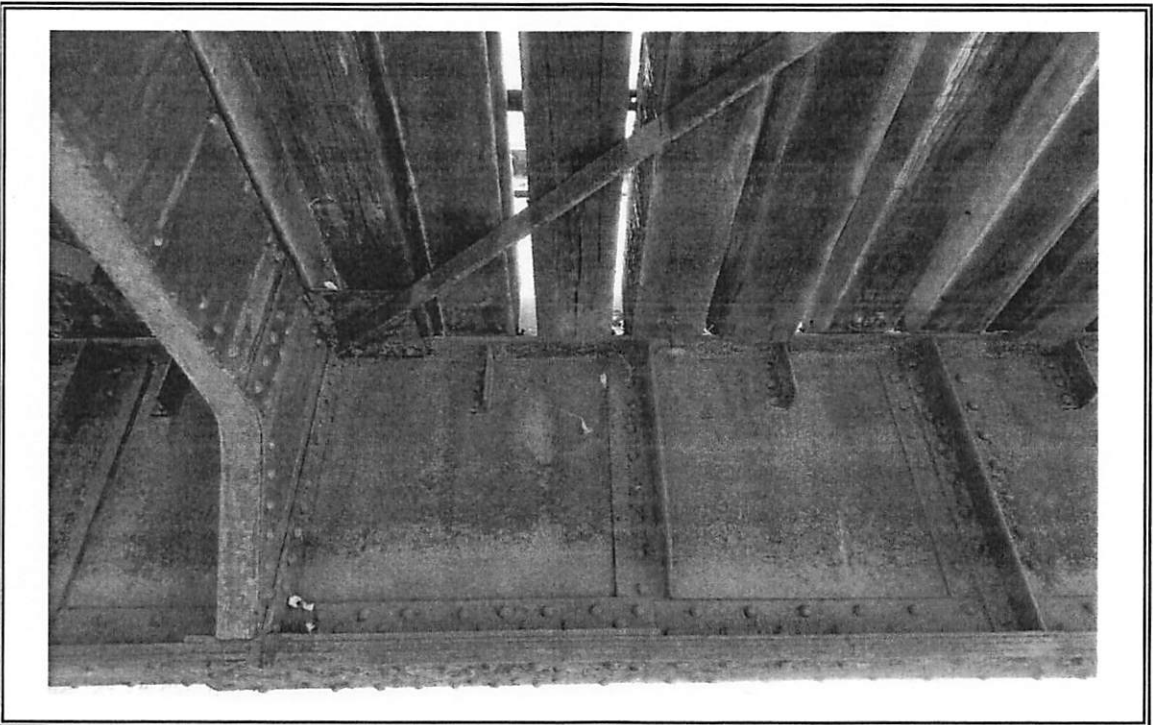
The timber deck is severely deteriorated and in poor condition. More than half of the timbers show visible rot and deterioration, including holes and soft/decayed wood. A number of timbers appear to be held in place only by their connection to the rail tracks.

Deck Configuration (Above)

Replacement of the timber deck system is proposed. The existing timber deck will need to be removed and replaced to meet the needs of the proposed trail.

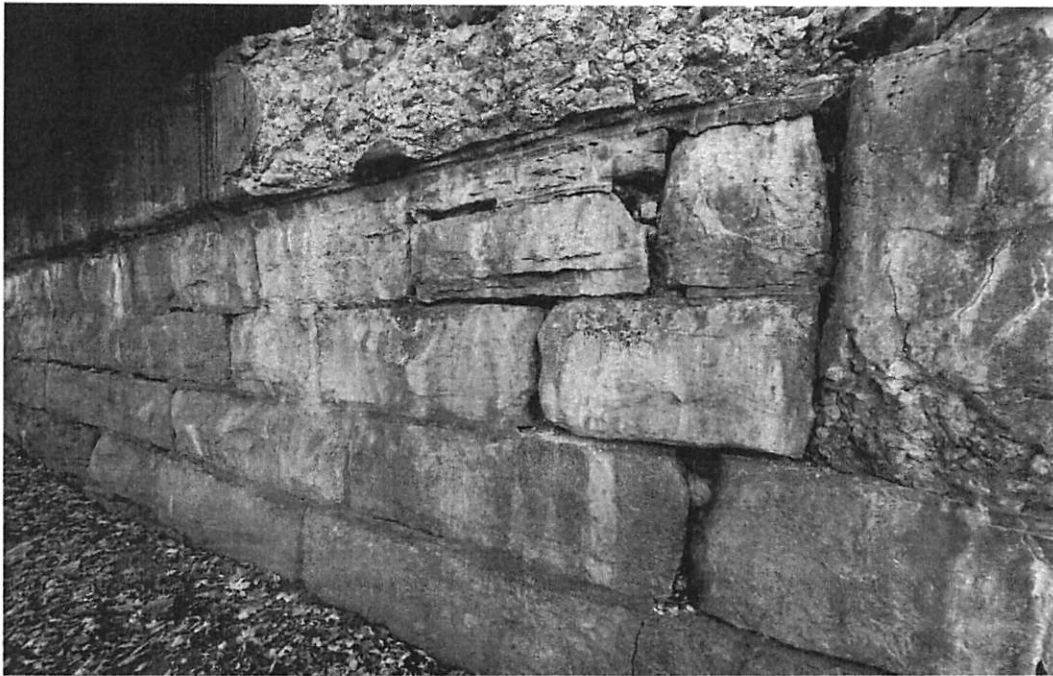
Photo No. 5

Typical Masonry Deterioration

Tuck point and pressure grouting repair is proposed for the stone abutments. This work is needed to eliminate existing voids to extend the service life of the existing abutments. It is anticipated that this work can be performed from the bank and will not require cofferdams or water access.

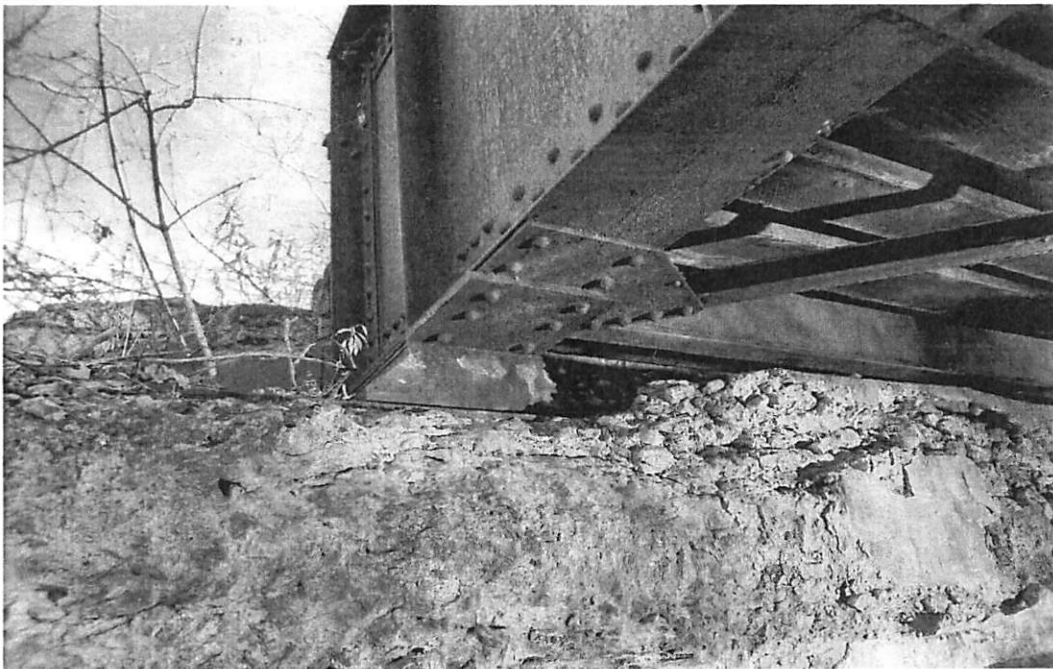
Photo No. 6

Typical Bridge Seat Deterioration

Class A and D concrete repair is proposed for the abutment concrete caps and wingwalls. This work is needed to address existing cracking and spalling, and eliminate potential bearing undermining to extend the service life of the existing abutments. It is anticipated that this work can be performed from the bank and will not require cofferdams or water access.

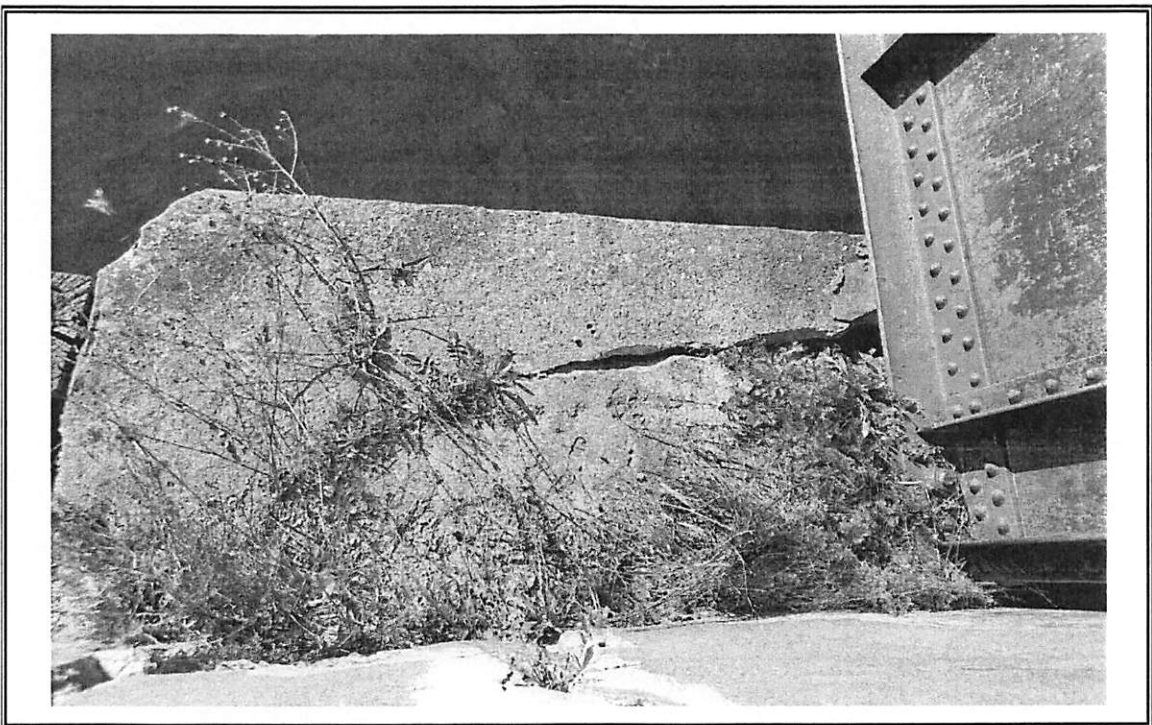
Photo No. 6

The north abutment is cast-in-place concrete and is in fair condition. The stem is in fair condition with minor spalling and cracking on the face of the abutment and an open crack (up to 3") on the bridge seat immediately in front of the bearing location. The bearing areas do not appear to be undermined by the open crack on the bridge seat. The concrete backwall is in fair condition with minor cracking.

East Abutment Seat Crack

Class A and D concrete repair is proposed for the abutments and pier. This work is needed to address existing cracking and spalling, and eliminate potential bearing undermining to extend the service life of the existing substructures. It is anticipated that this work will require cofferdams or water access.

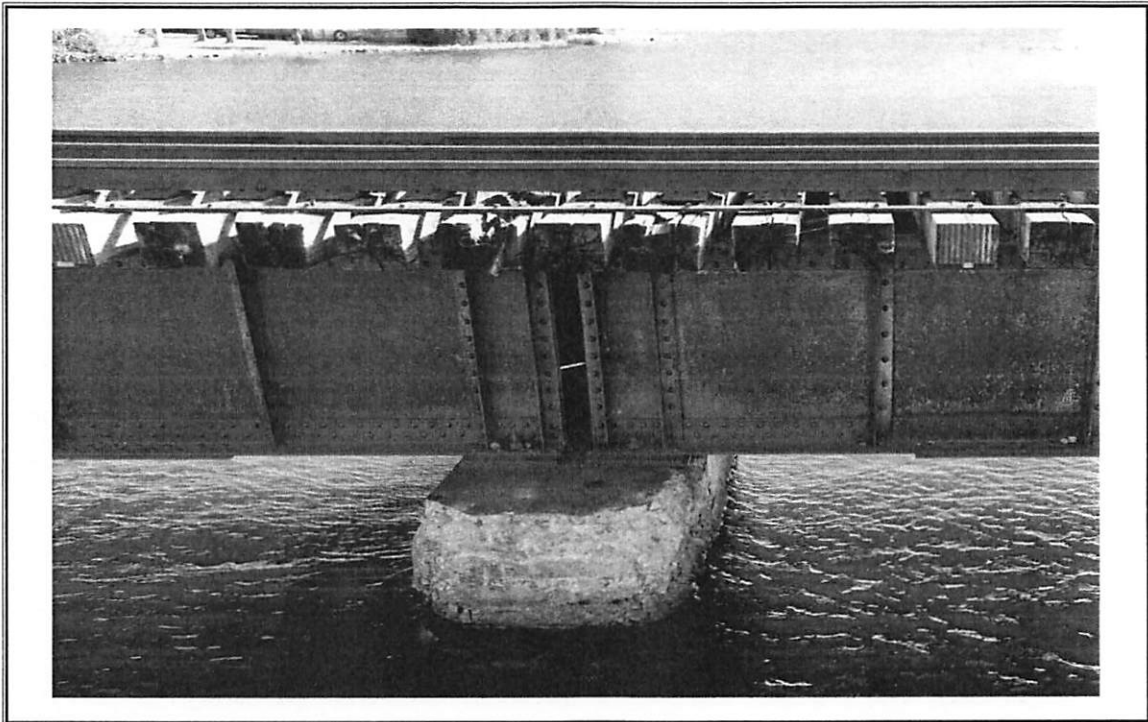
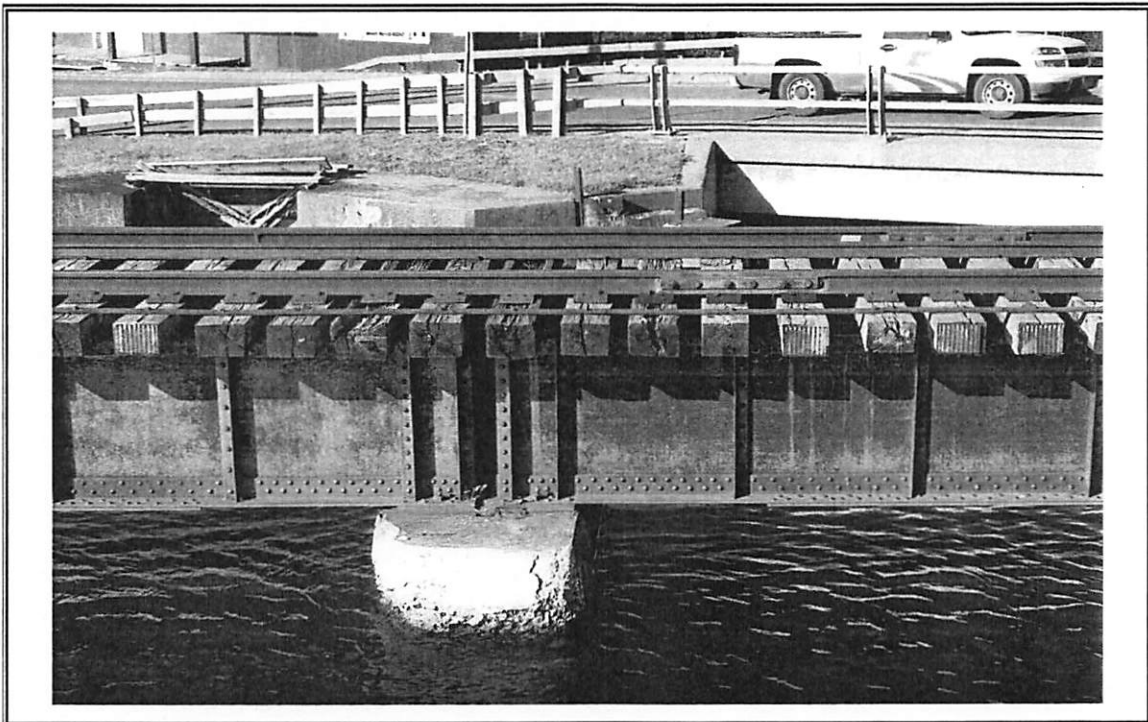
The pier is cast-in-place concrete and is in fair condition. The pier exhibits moderate deterioration with spalling at the upstream and downstream noses and minor cracking throughout. The bearing areas are not undermined.

Pier

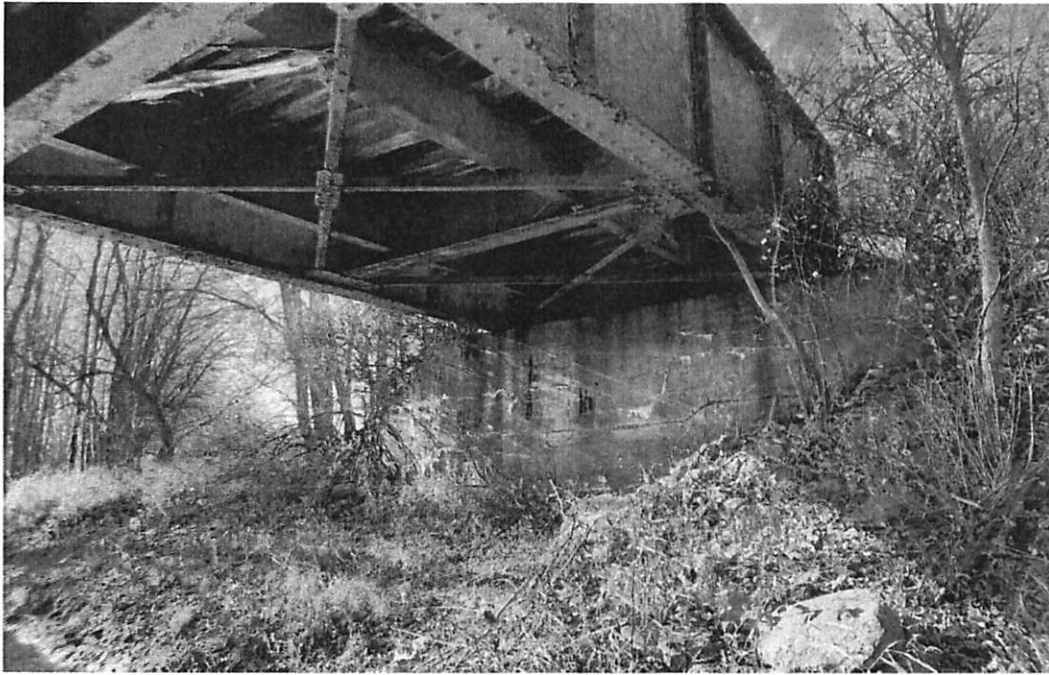
Photo No. 3

The west abutment is a cast-in-place concrete abutment with concrete wingwalls and is in fair condition. The abutment stem and wingwalls exhibit minor surficial horizontal and vertical cracking and minor efflorescence. The bearing areas are not undermined. The concrete backwall is in fair condition with minor spalling.

West Abutment

No concrete repair is proposed at the west abutment. Existing deterioration is minimal and does not require rehabilitative work to extend the service life.

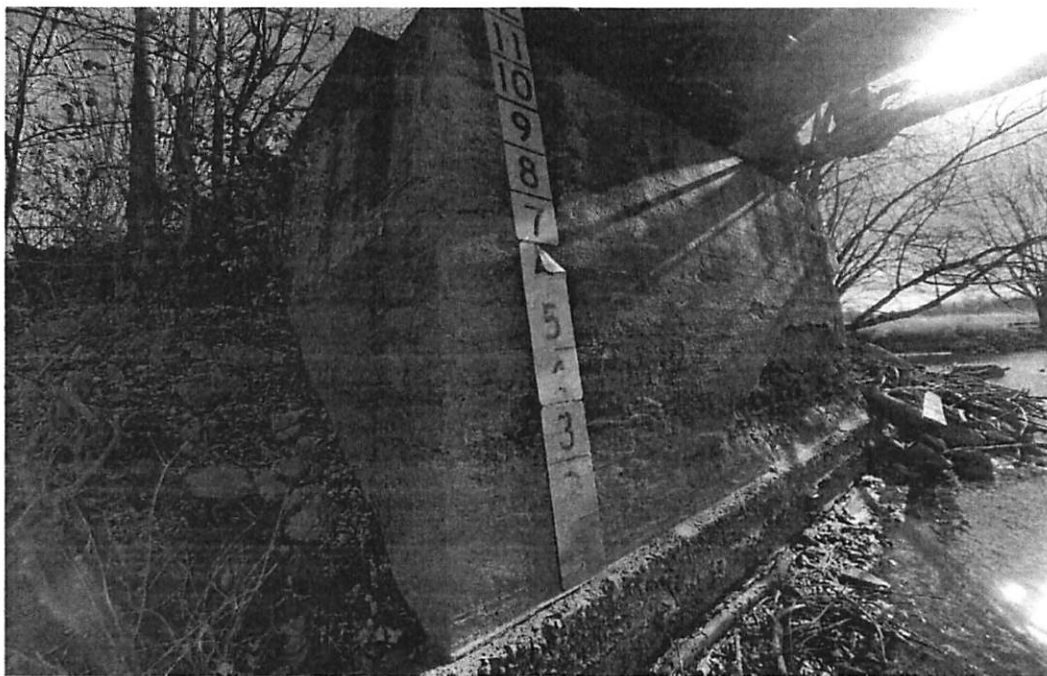
Photo No. 11

The east abutment is a cast-in-place concrete abutment with concrete u-walls and is in poor condition. The abutment stem is in poor condition with deep spalling through the middle height of the stem and the south corner of the u-wall. The bearing area near the south corner of the abutment may be undermined by the deep spalling at this location. The concrete backwall is in fair to poor condition with cracking and spalling.

There is no evidence of scour at the west abutment. The toe of the footing at the east abutment is exposed above grade over the full length of the abutment. The scour condition at the piers could not be inspected at this time. It is unknown if scour is occurring at the piers.

East Abutment

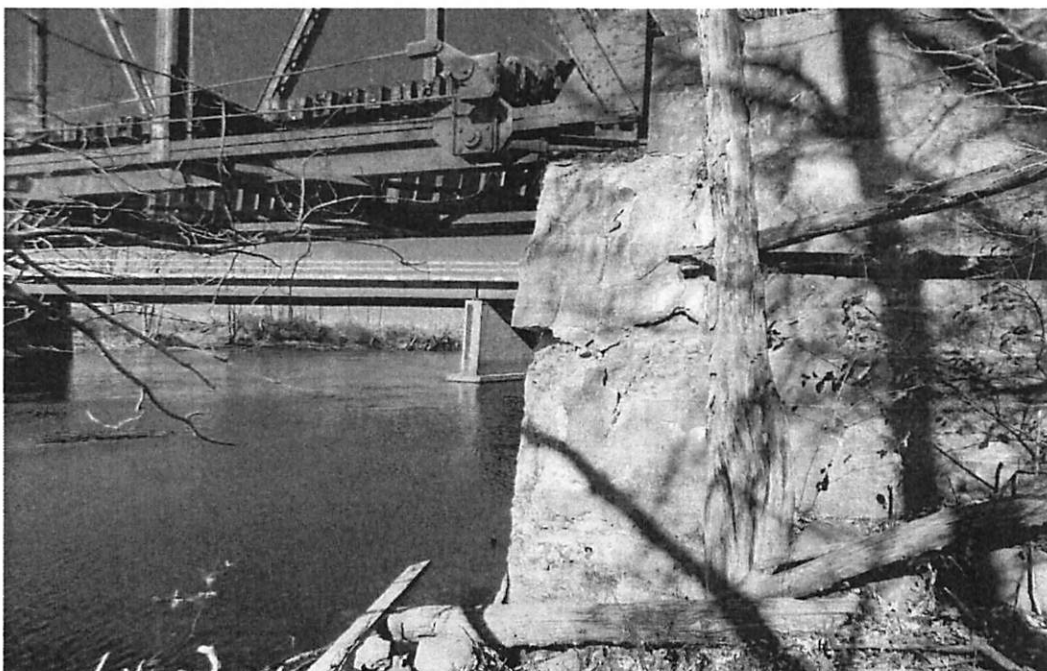
Photo No. 12

East Abutment and U-wall

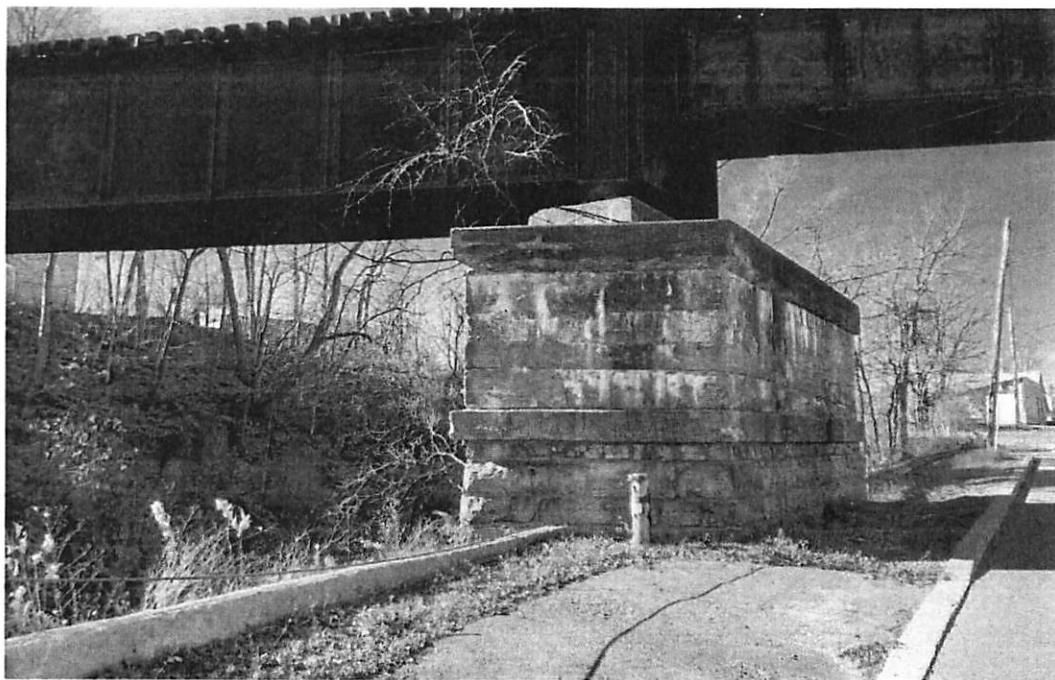
Photo No. 5

The pier is a stone base with a 6' deep concrete cap and concrete pedestals, and is in fair condition. The stone base is in fair condition. There are no apparent issues with mortar quality or loss between stones. The concrete cap is in fair condition with spalling, cracking, and efflorescence. The concrete pedestals are in fair condition with spalling, cracking, and efflorescence. The bearing areas are not undermined.

Pier

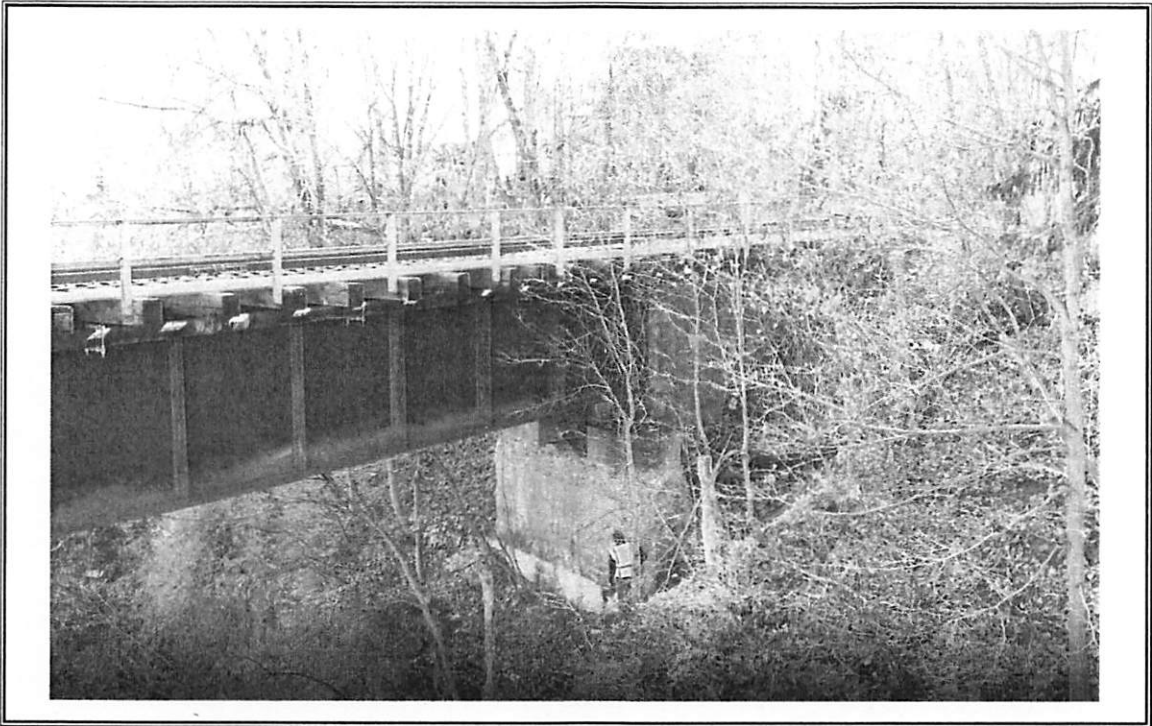
Photo No. 7

The south abutment is a concrete abutment constructed in front of a stone u-wall functioning as a backwall, and is in fair to poor condition. The stem of the concrete abutment is in poor condition, with 2"-6" deep spalling over more than half of the surface area. The concrete pedestals are in fair condition with minor cracking. The bearing areas are not undermined. The stone u-wall is in fair condition. There are no apparent issues with mortar quality or loss between stones.

South Abutment
